**NASA TECHNICAL
MEMORANDUM**

NASA TM X- 62,471

**FIRE SAFETY EVALUATION OF AIRCRAFT LAVATORY AND
CARGO COMPARTMENTS**

August 1975

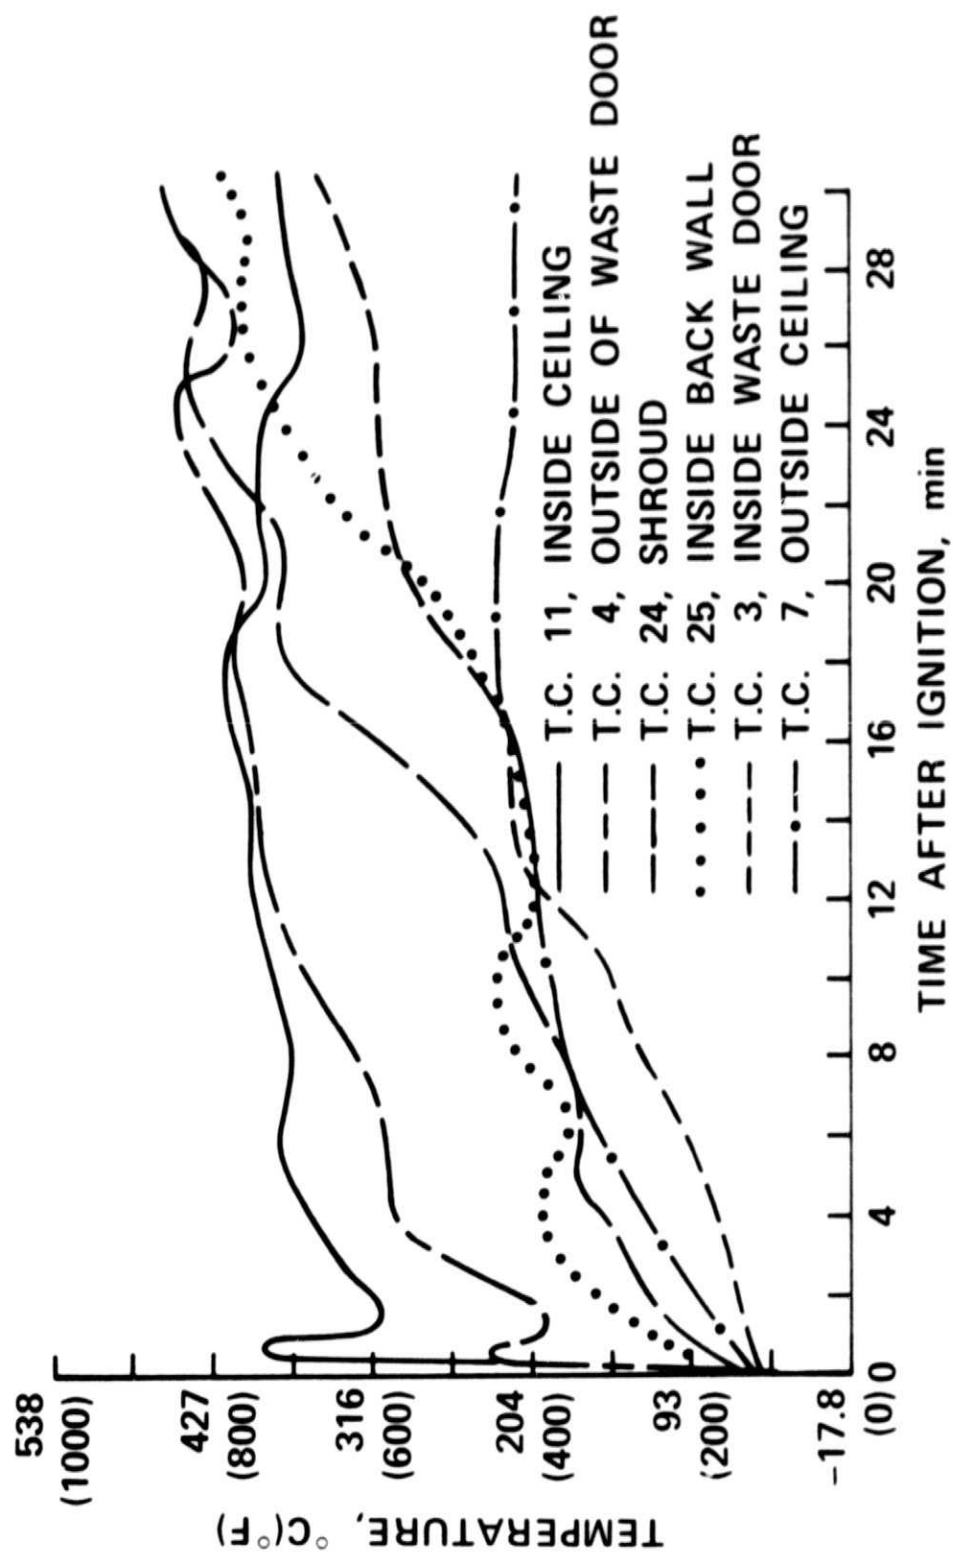
Figure 8.—Surface temperature in lavatory.

Figure 8 presents the readings of some of the thermocouples on the test lavatory. Thermocouples inside the lavatory were 2.54 cm (1 in.) away from the surface to obtain the environment temperature. The thermocouples inside the lavatory were numbers 4, 11, 24 and 25. The other thermocouples were bonded to various lavatory surfaces.

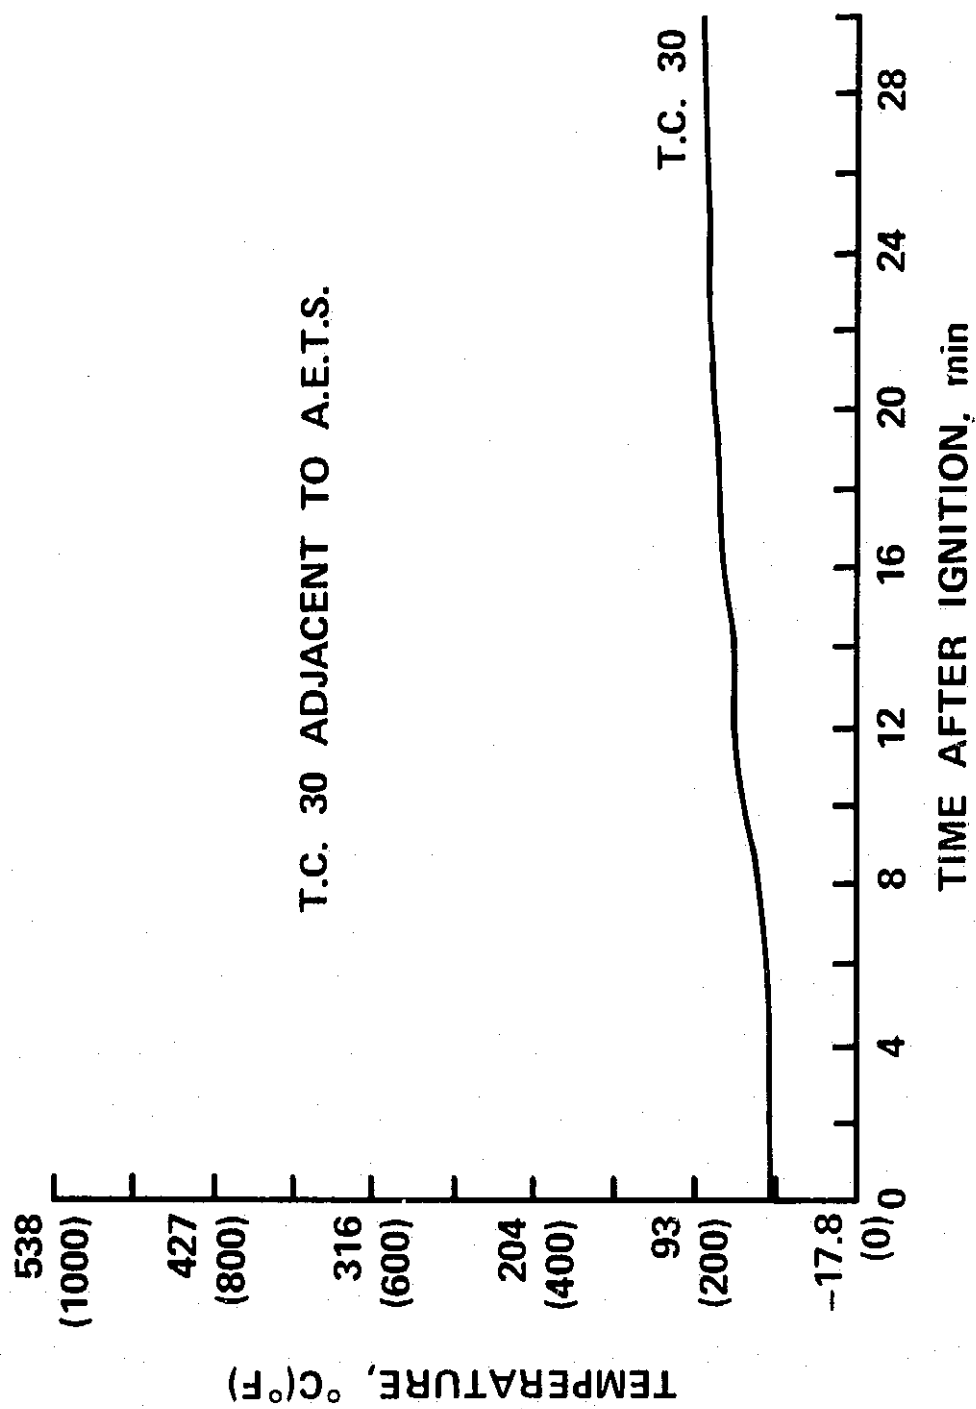
Figure 10.—Air temperature in enclosure.

The temperature recorded adjacent to the AETS cage is shown in figure 10. The mice died approximately 18 minutes after test initiation.

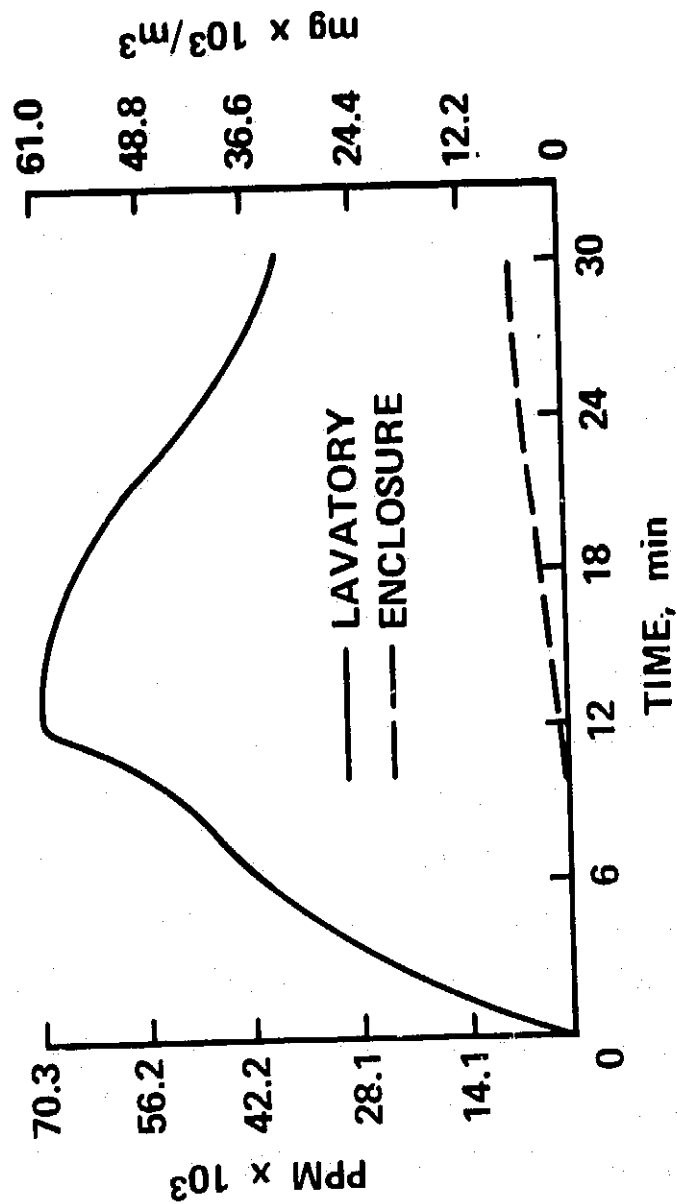
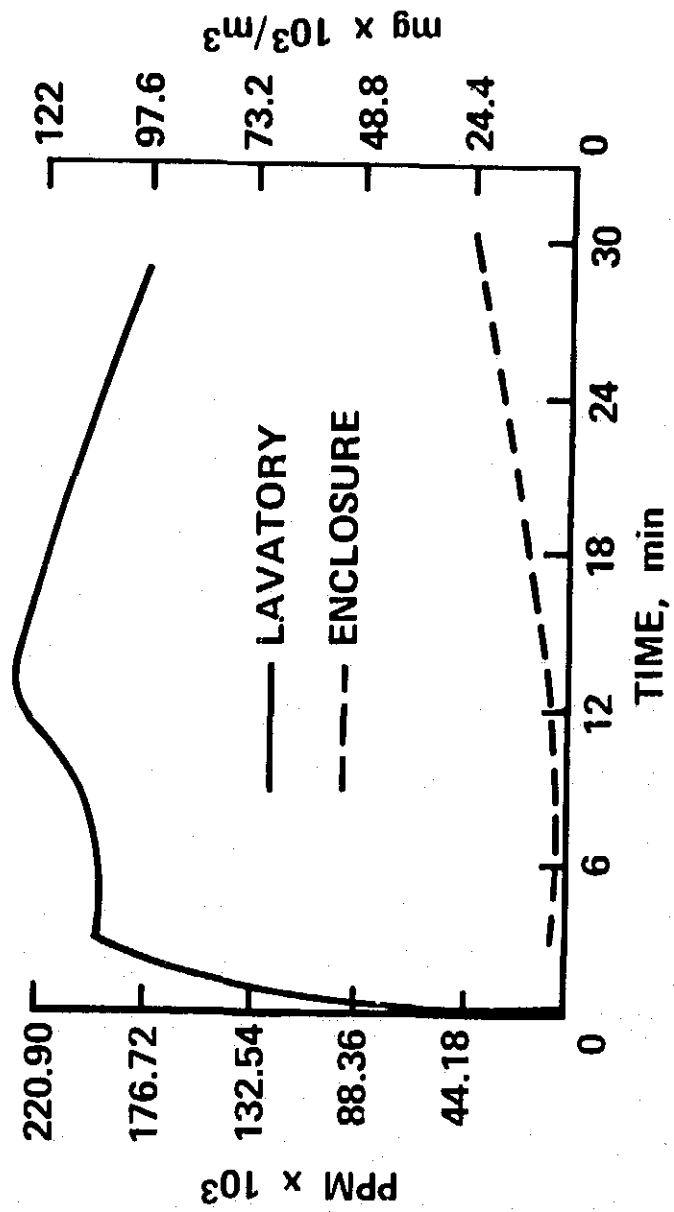
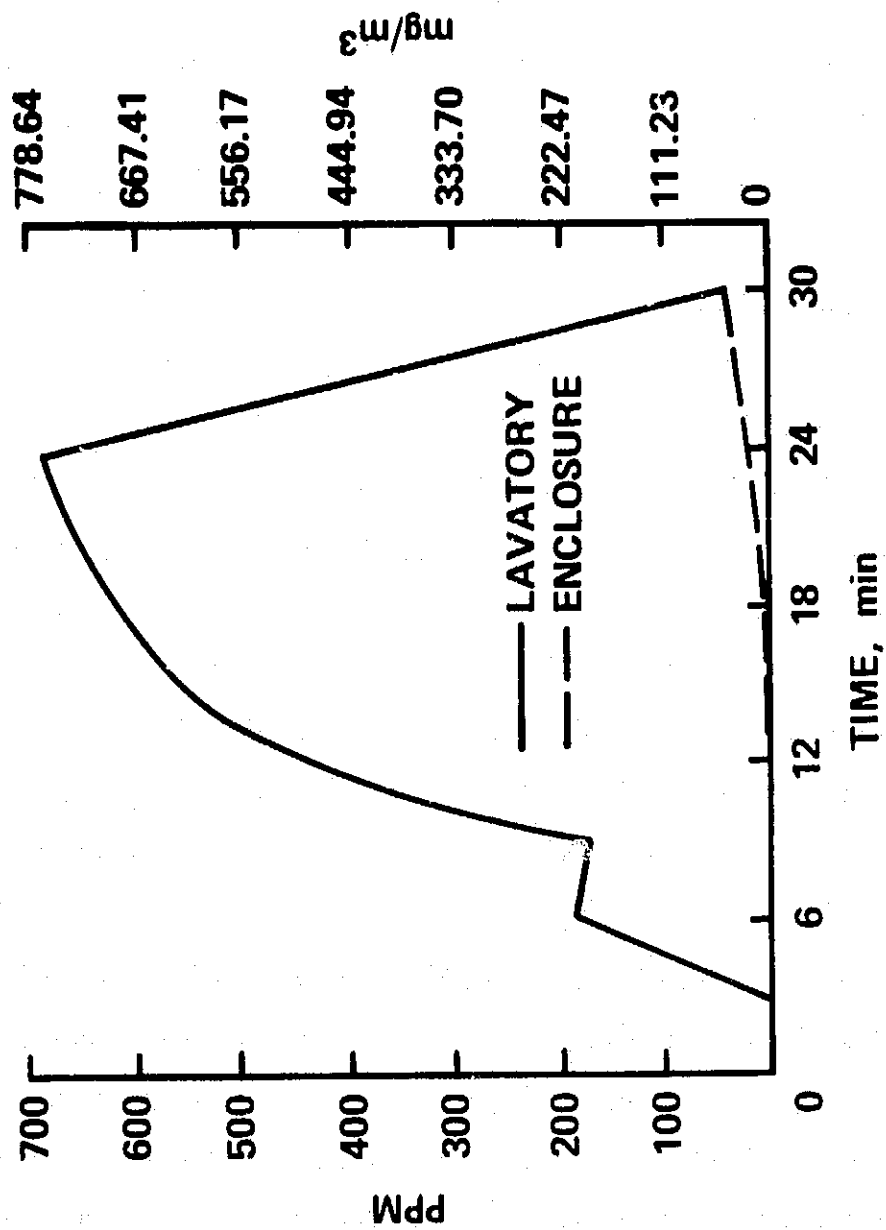
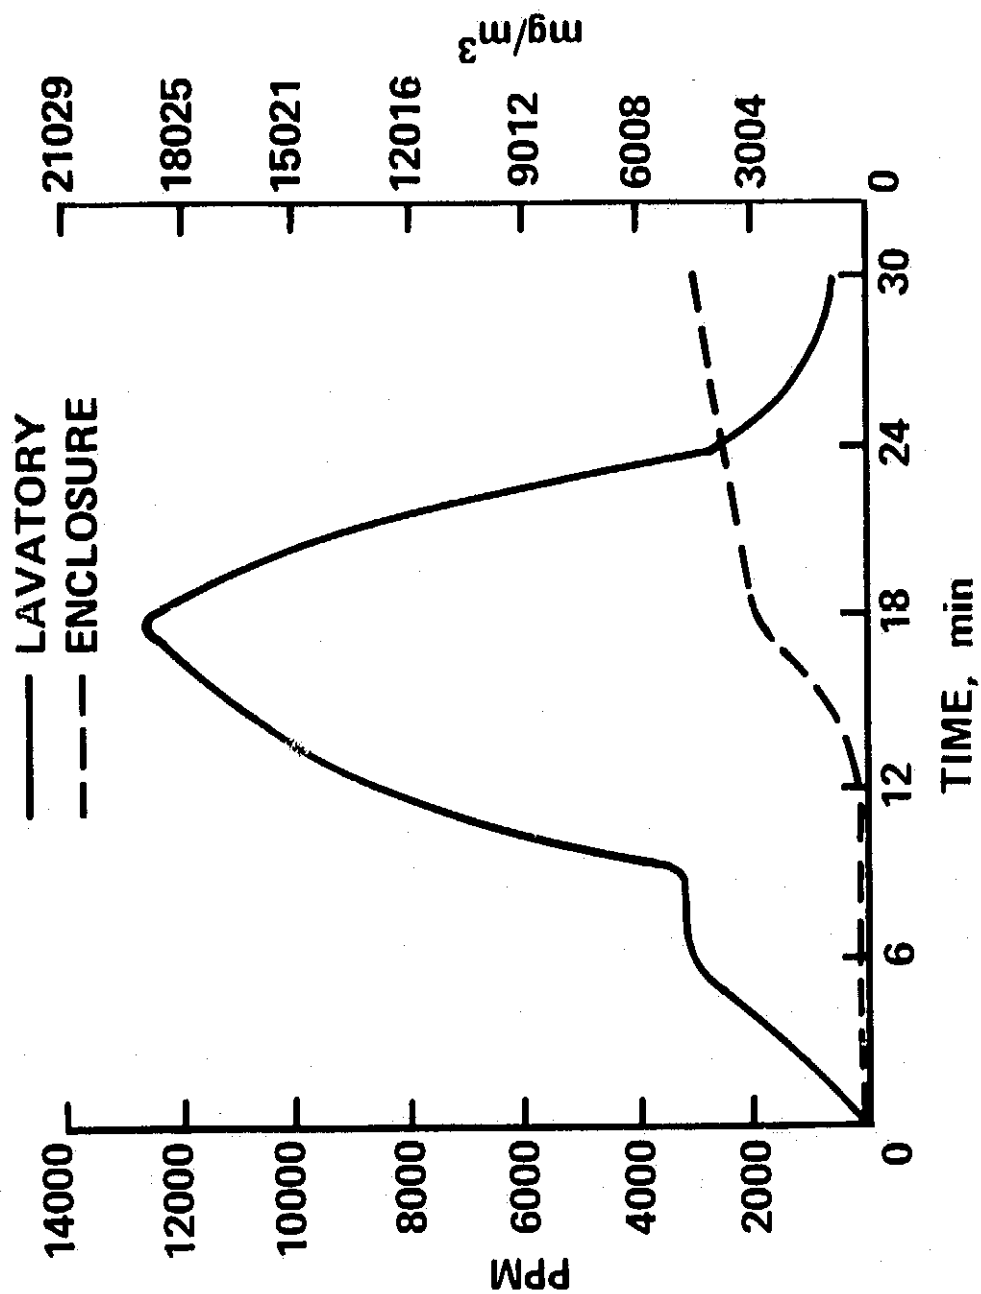
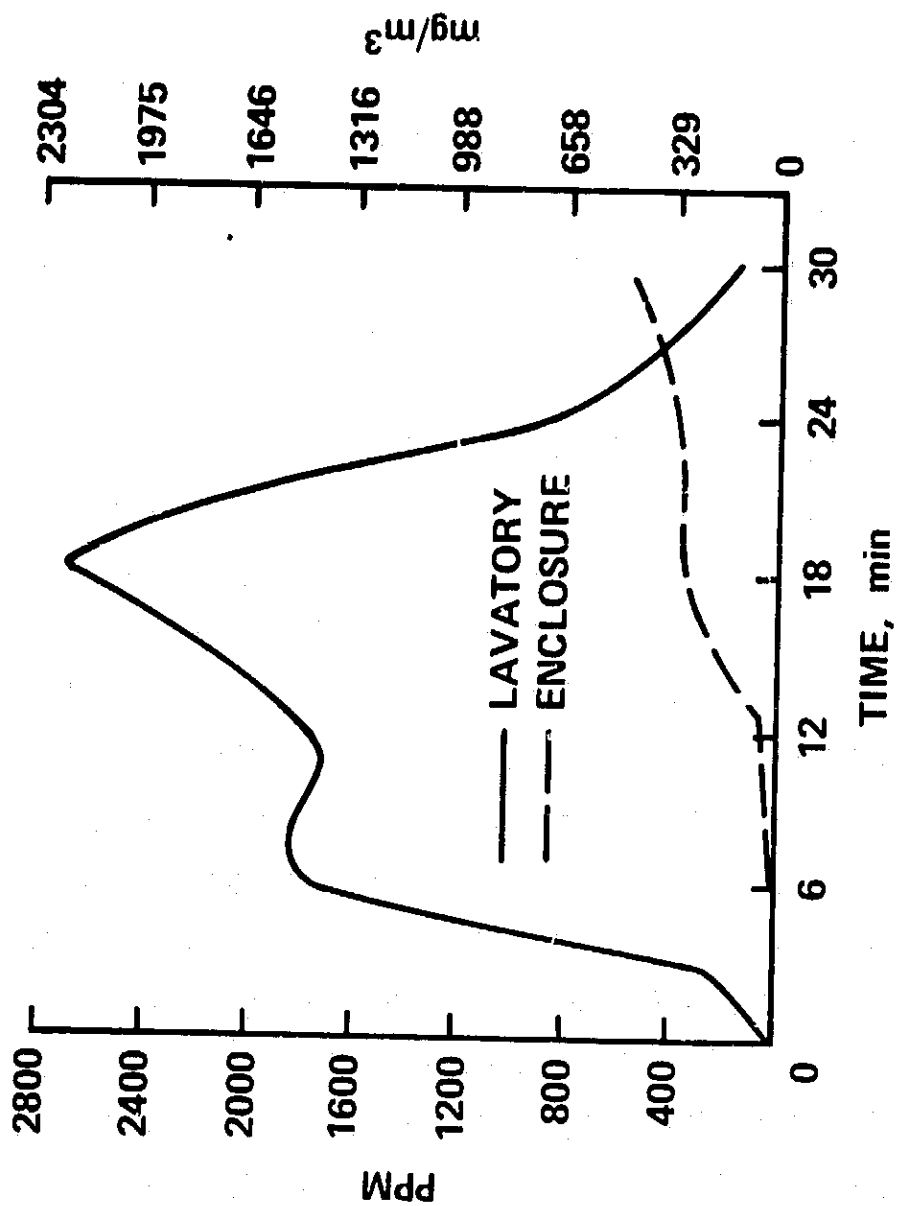
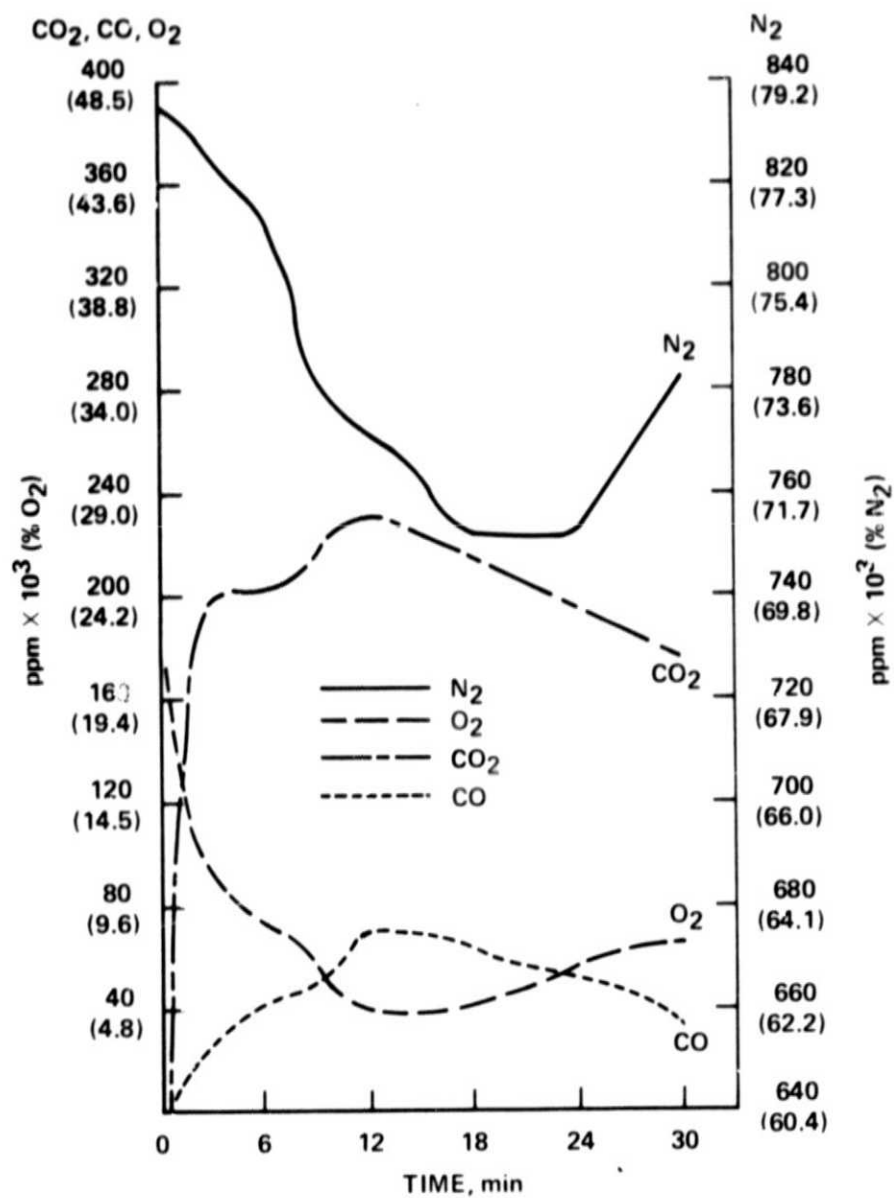
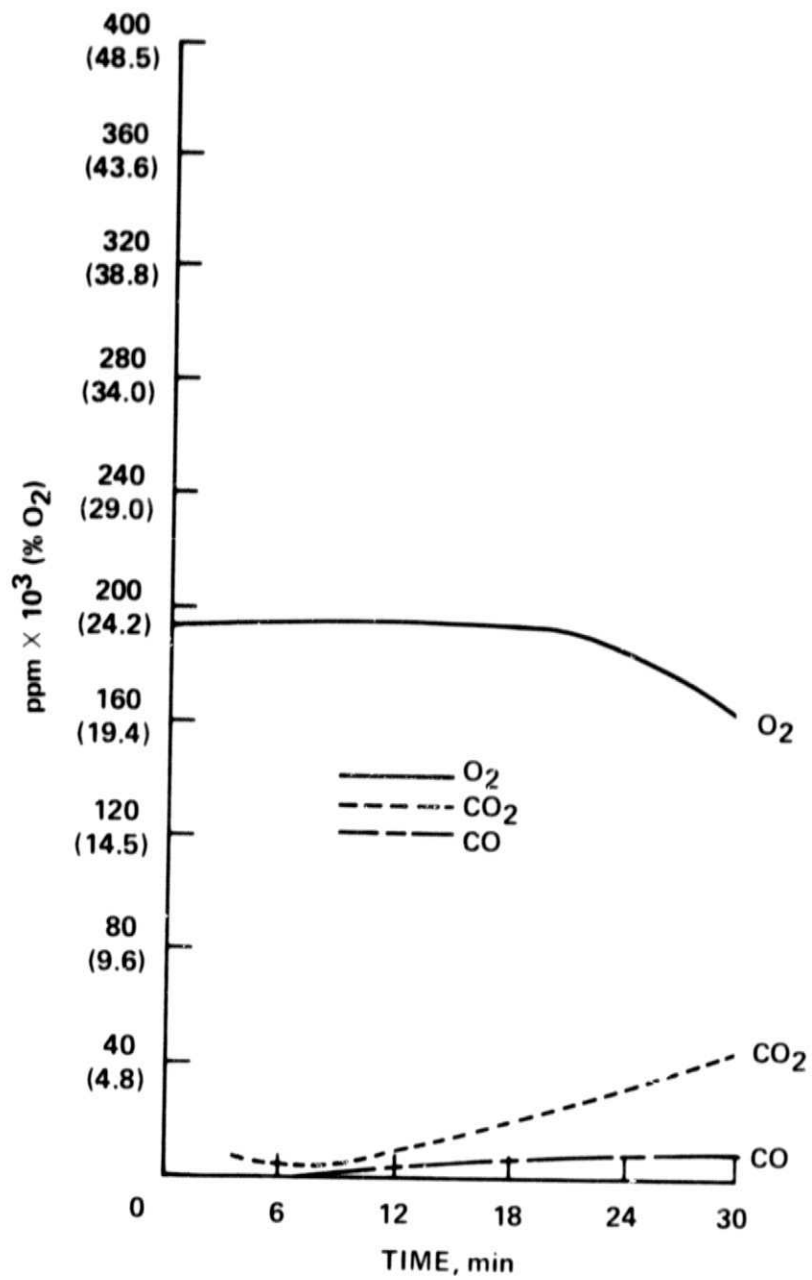
Graphs of the concentrations of the atmospheric gases and toxicants in the lavatory and test enclosure against time are shown in figures 11 - 17. Two episodes of toxicant production are indicated. Large amounts of HF, HCl, and CO, and severe oxygen depletion were observed at the beginning of the fire during the first episode. Very little HCN was produced. Probably during this period rapid burning of the waste fuel was occurring, with HCl and HF forming respectively through pyrolysis of the polyvinyl chloride floor mat and the polyvinyl fluoride surface of the lavatory interior.

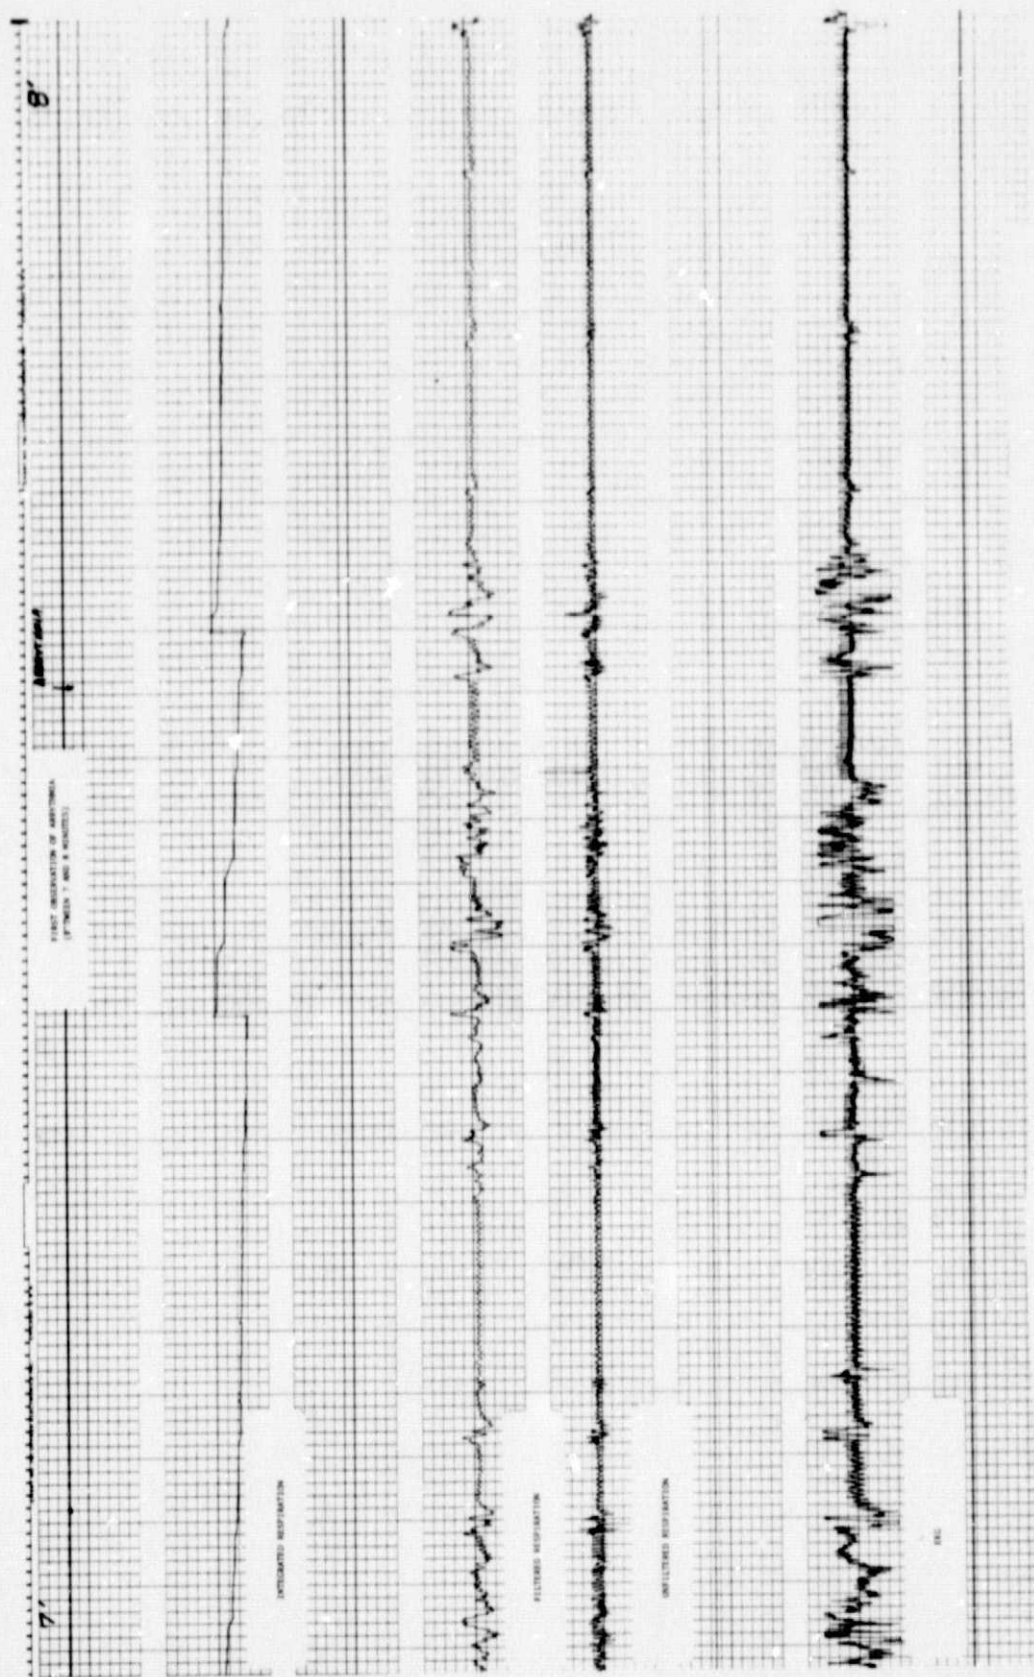
Figure 19.—First observation of arrhythmia (between 7 and 8 min).

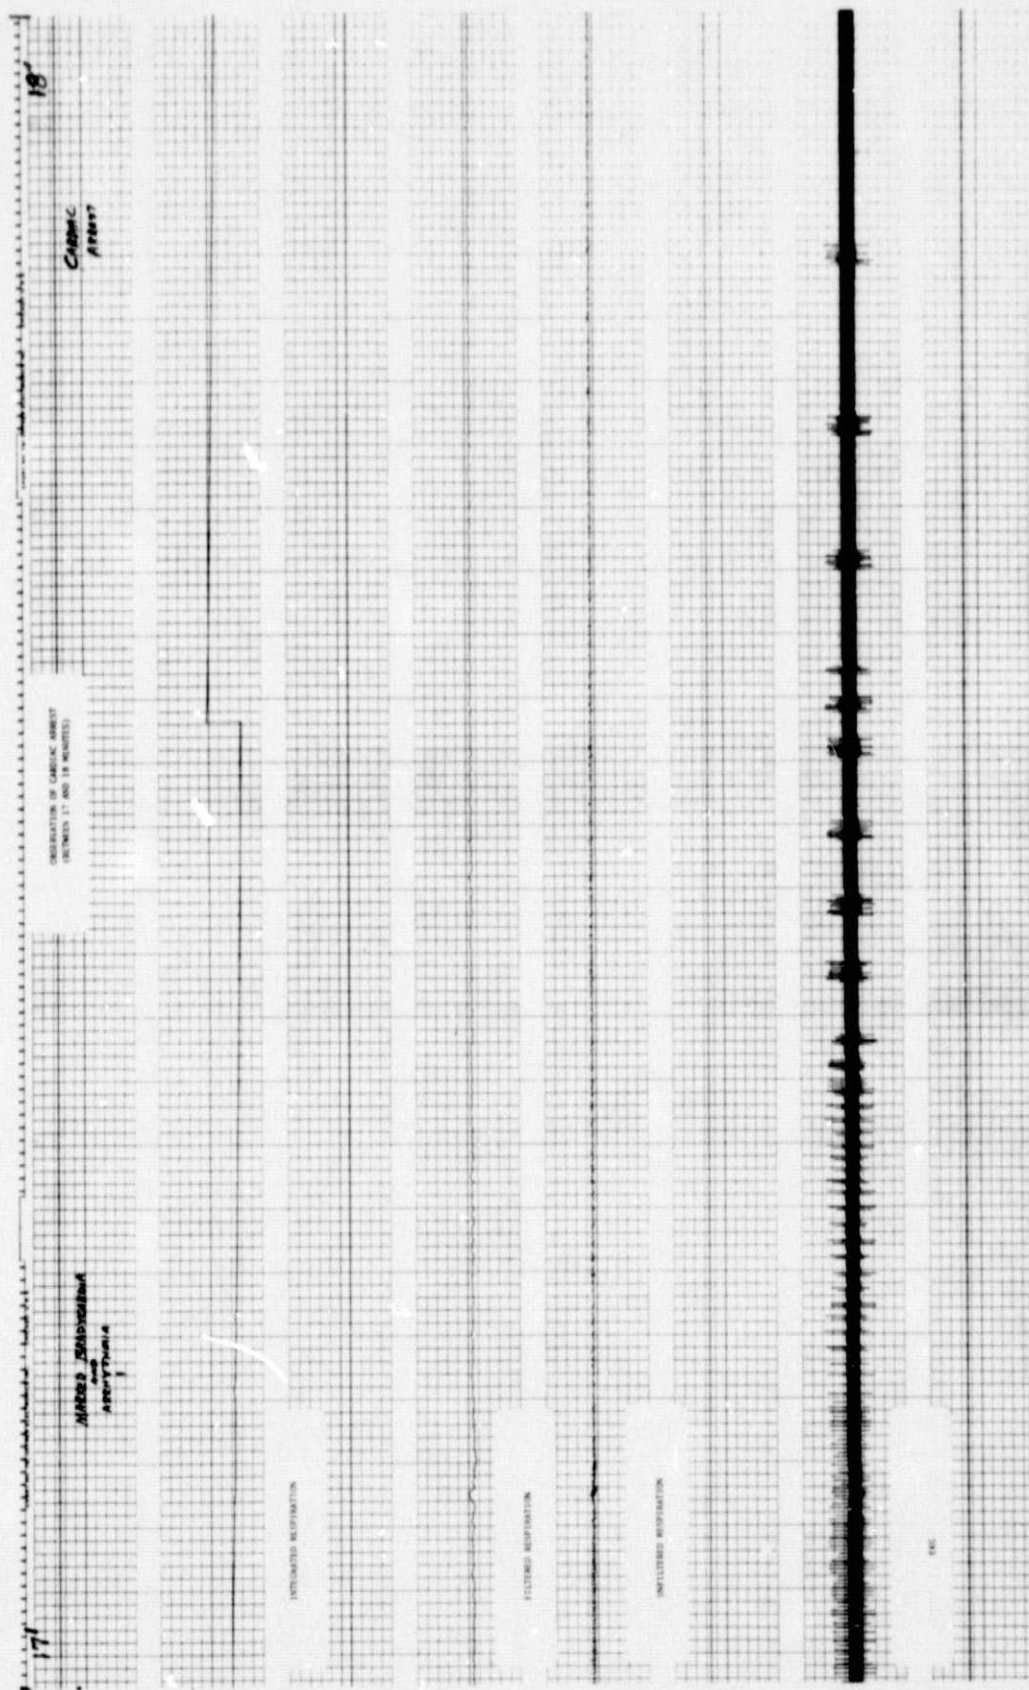
Figure 20.—Observation of cardiac arrest (between 17 and 18 min).
